## **Demonstration and Validation of Materials for Corrosion-Resistant Fencing and Guard Railings in Aggressive Climates**

Final Report on Project F09-AR02

Christopher Olaes, Richard G. Lampo, and Lawrence Clark

October 2015

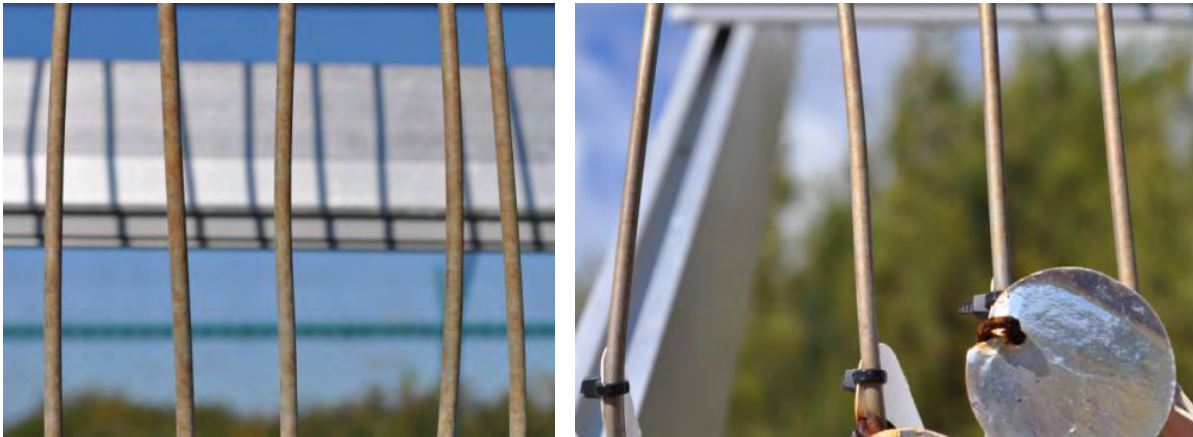
Figure 20. Stainless steel wire coupon at FRF (left) and KTA (right) after 6 months of exposure.

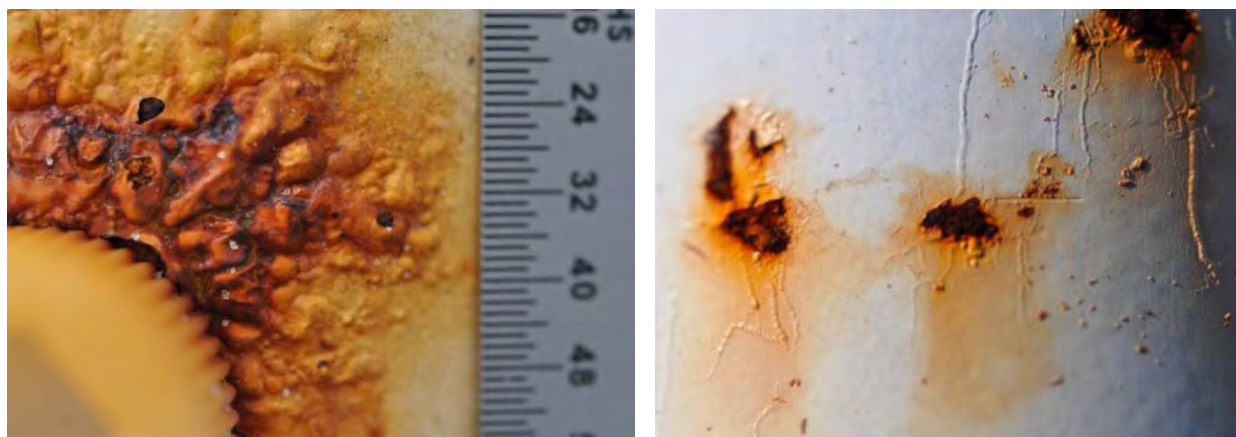
Figure 34. Coated steel railing coupon at FRF (left) and KTA (right) after 12 months of exposure.

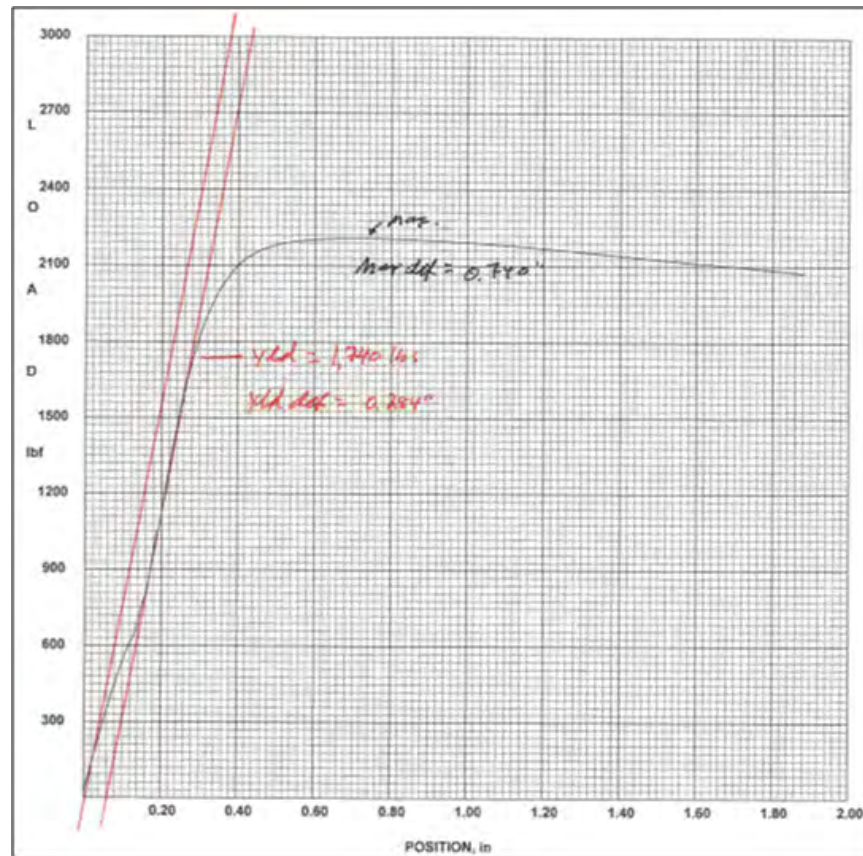
Figure 46 shows a typical graph of steel pipe deformation as a flexure load is applied. It was found that the longitudinal shape of the pipe remained rigid and the circular cross section collapsed before the pipe began to flex, as seen in Figure 47. This same behavior was not observed in the aluminum or FRP railing specimens. The aluminum specimens were relatively ductile in comparison with steel and stainless steel, and therefore began to deform in both the cross section and longitudinally at the same time. The FRP railing had a square cross section and is not very ductile compared to either steel or aluminum, so its failure was different than the metallic specimens. Figure 48 – Figure 50 represent the change in the tangent modulus throughout the exposure period for each test site. More data can be found in Appendix E.

Figure 46. Typical load-deflection plot of a steel pipe during flexure testing.

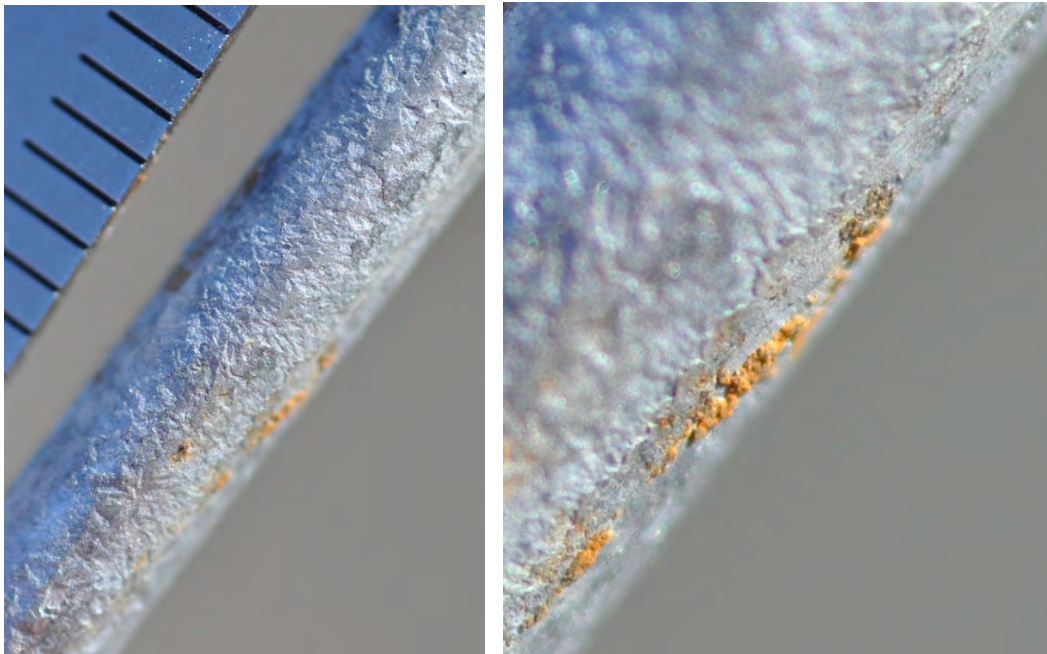
Figure A14. Aluminized after 12 months exposure showing corrosion on less than 5% of the total surface area.

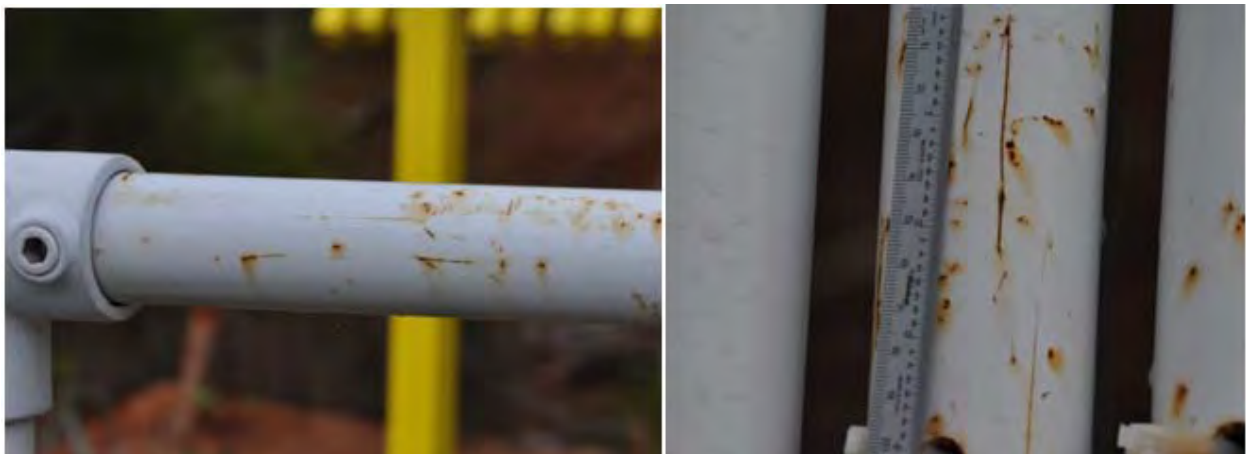
Figure B66. (Left) Stainless steel coupons facing away from the ocean; (Right) stainless steel coupons facing the Ocean.

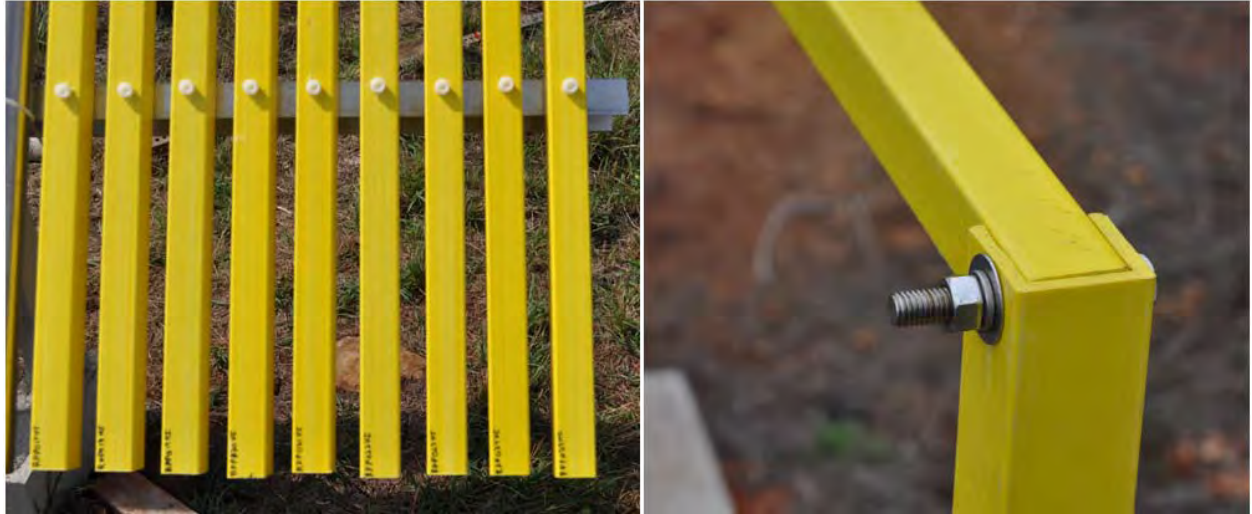
Figure B67. (Left) Painted carbon steel railing coating failure. (Right) Painted carbon steel coupon coating failure.
